Non-Invasive Condition Report

Prepared for: Mr Smith

2211 Sample Street
Orakei

Inspected by:
John Naisbett
Buysafe Home Inspections Ltd

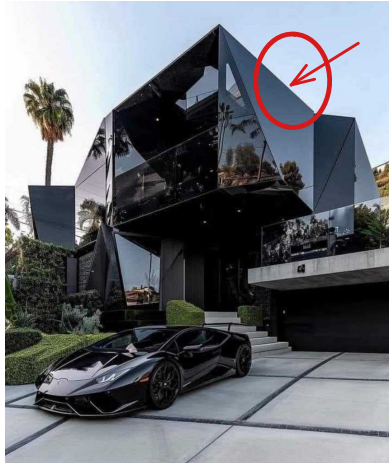
Roof Condition: Maintenance to required - Due to the amount of roof junctions where the roof changes pitches and lack of roof overhang we would highly recommend a license (ROOFER) inspects the roof and flashings in place due to risk of Weather Tightness.

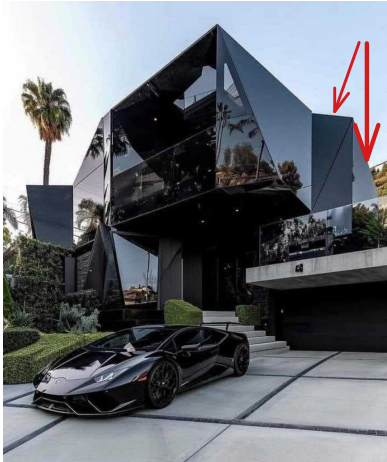
Flashings: License roofer to inspect - Some of the front roof flashings are lifting, we would recommend a license refer checks the roof fixings to ensure Weather Tightness of the home.

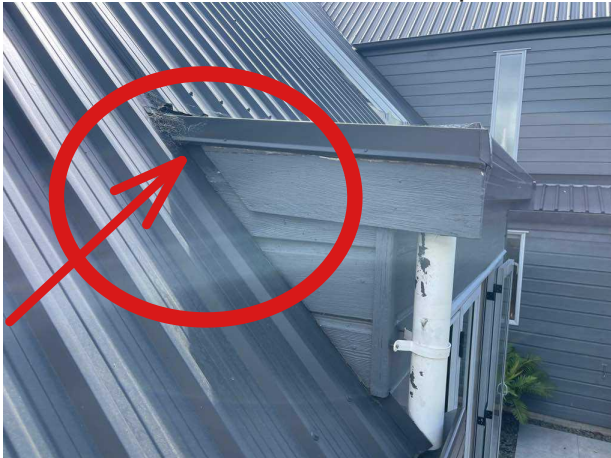
Barge Boards: Painted timber - The timber barge board is too short leaving a gap at the end this will need to be replaced

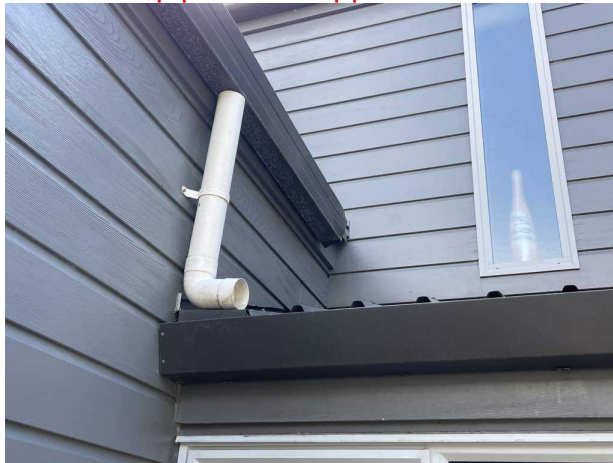
Downpipe: PVC/Plastic - We would recommend downpipe spreaders are installed where the pipes from upper ruse are discharging onto a low roof

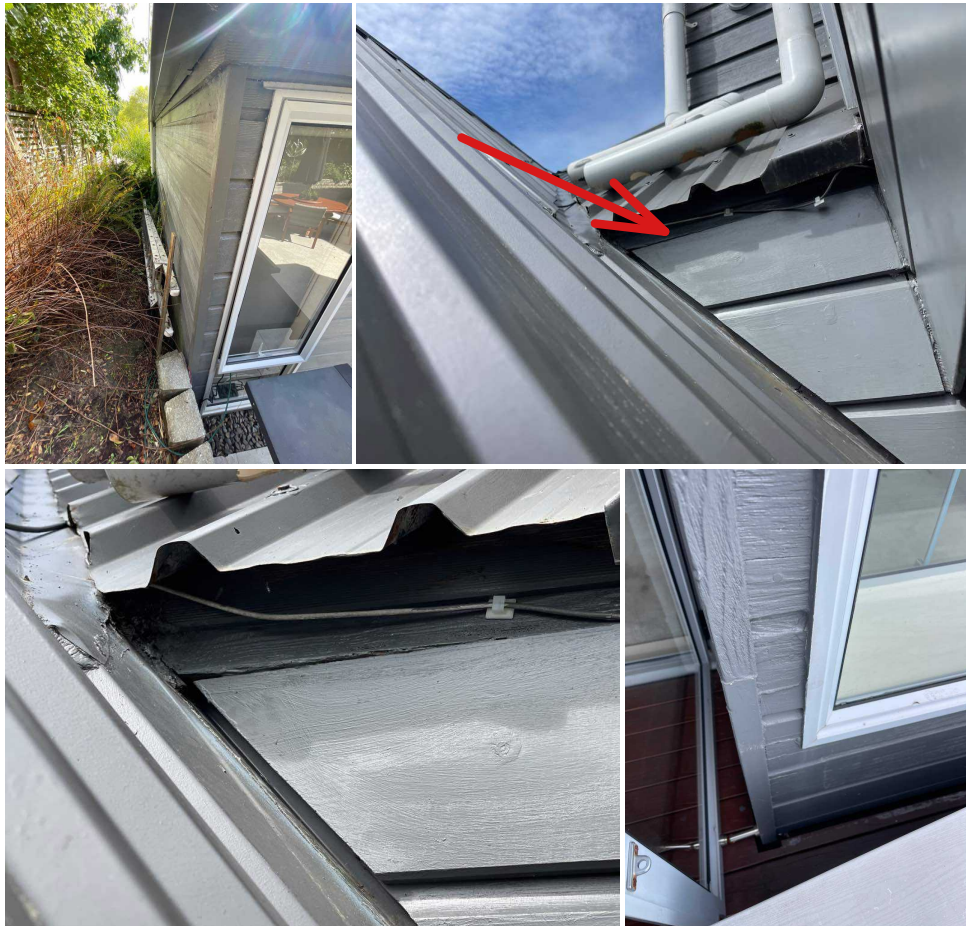
Cladding Condition: General maintenance and repairs will be required - The cladding will need general maintenance to ensure Weather Tightness of the building.

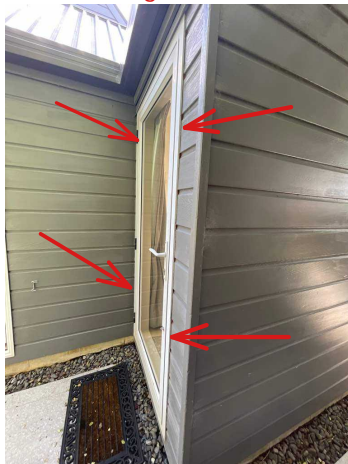
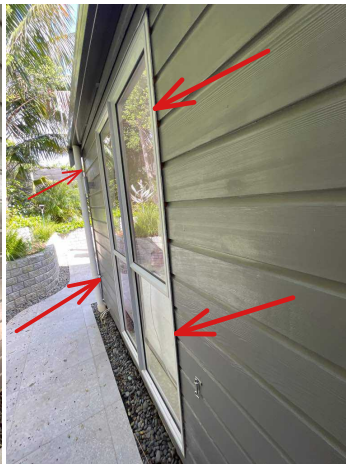
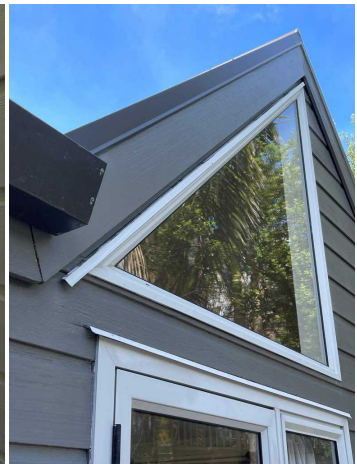
Joinery Condition: Aluminium - We would highly recommend side scribes are installed to all windows and doors to ensure Weather Tightness are home..

We would recommend the roots skylight is closely inspected on its flashings due to Weather Tightness risks.

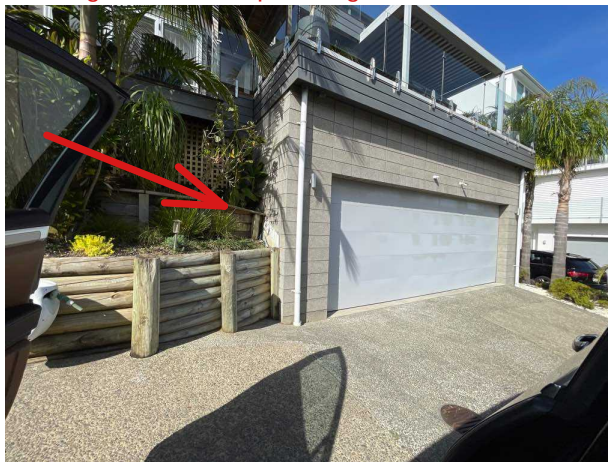
Ground Levels/Heights: Drainage contractor to inspect the drainage - **Ground levels higher than the floor level of the home is always classed as a high risk. This strictly relies on good drainage and Waterproofing. we would suggest a licensed drain layer checks the drainage and Waterproofing on its condition**

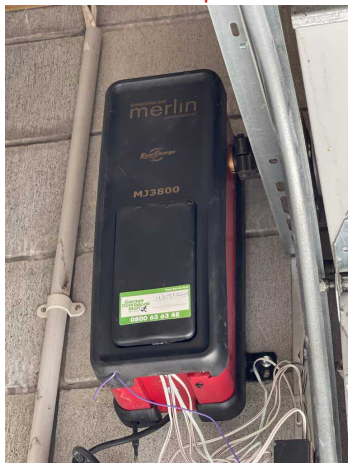
Door Operation: Mechanized - **Side mount motor Merlin. As the Door is of a large type door over 6 meters long, we would recommend checking with a licensed Door specialist that this is adequate.**

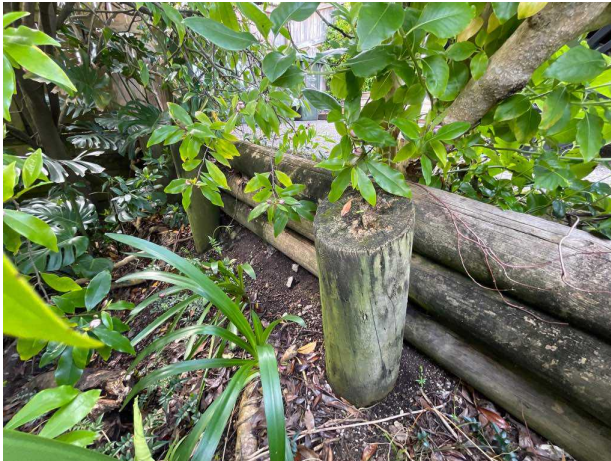
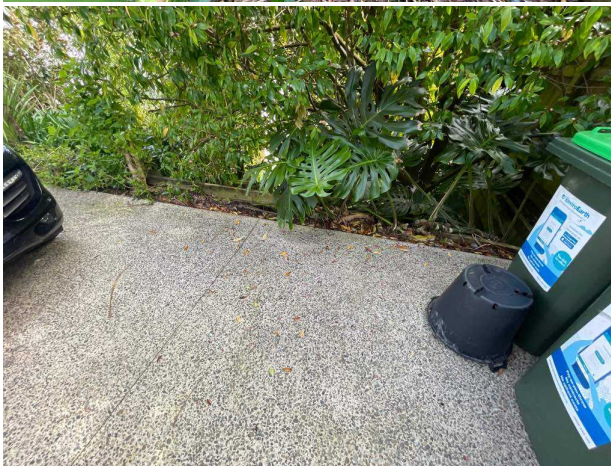
We did notice at the rear of the section the keystone is starting to move forward these areas may require removing and replacing.

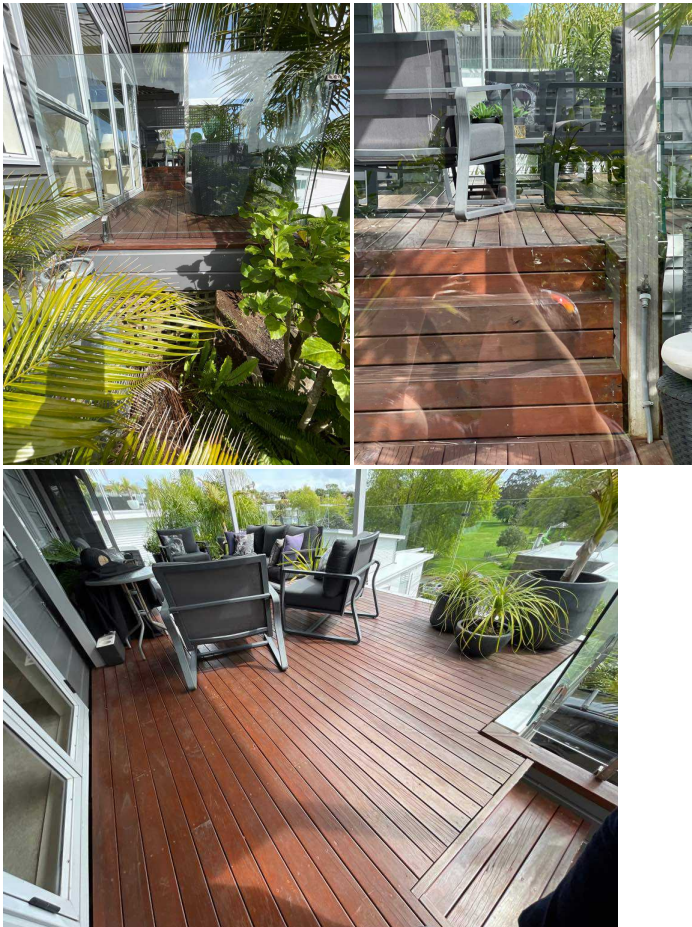
The dick plate has been bolted directly onto the weatherboards this should be spaced off the cleaning by a minimum of 12 mm is water camp come trapped causing rot to the weatherboard timber structure and behind

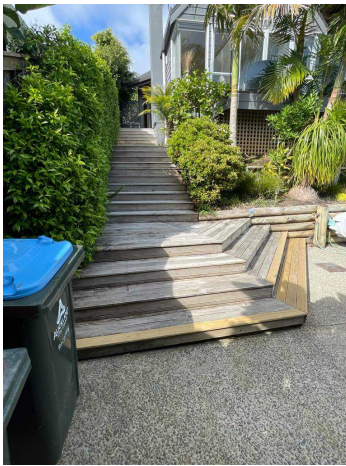
Stairs Timber - Tim Steve on the left side of the home of a reasonable condition some areas have been replaced on the bottom timber structure under this is not accessible, so we cannot comment on the condition

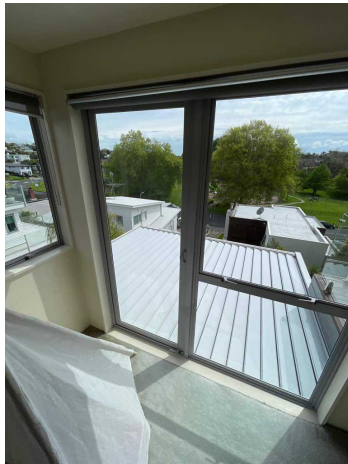
Doors: Aluminum - This door opens up to the outside which is on to a louvre roof System the door should be permanently closed it only has one screw at the bottom

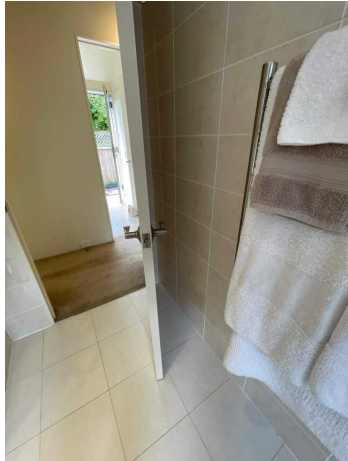
Internal Door: Hollow Core door - **No doorstop has been fitted when opening the door hits on the wall**

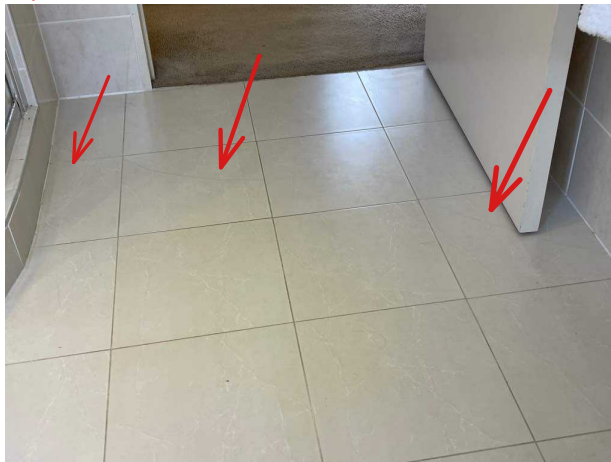
Floor: Tiled with no underfloor heating - **The floor tiles are cracked these will need to be replaced however the tiles may now not be able to be matched which may result to replacement on all walls and floors**

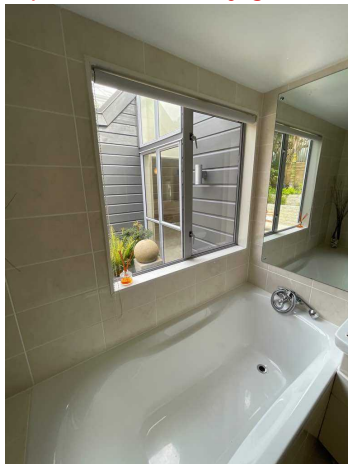
Windows: Aluminium - We noticed the glass in the window above the bath is not safety glass this can be dangerous if somebody slipped. We would recommend the glass is replaced for safety glass

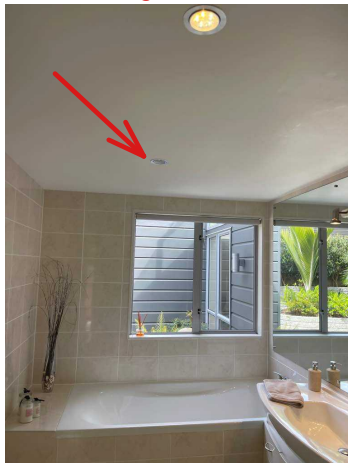
13. Defective, Not Inspected Electrical: Wiring has not been inspected or tested as part of this inspection - **The light is not working over the bath**

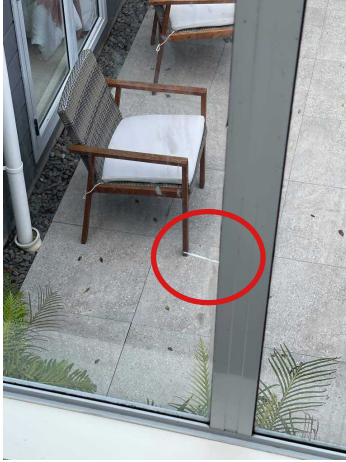
Windows: Glass to be replaced - **Glass cracked on the leftside window**

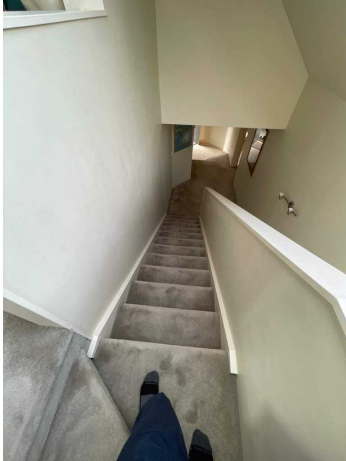
Handrails: Not fitted - **A handrail will need to be installed**

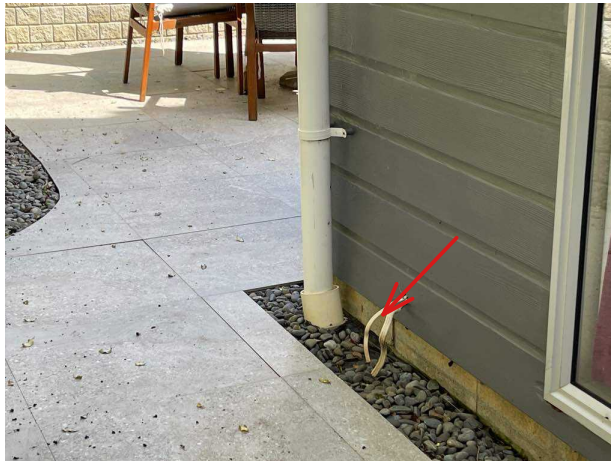
The wires coming out the wall will need to be checked these are not live we would recommend checking the fuse can't be switched on to make these live due to electric shock concerns.
