Non-Invasive Condition Report

Prepared for: Mr Smith

2211 Sample Street
Orakei

Inspected by:
John Naisbett
Buysafe Home Inspections Ltd

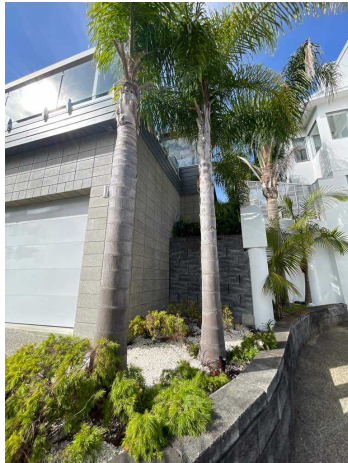
Exterior cladding: Concrete block - **The left and right side of the garage the cladding his Gardens against it we would suggest the drainage in Waterproofing is inspected by a licensed contractor and some cases the area will need to be updated.**

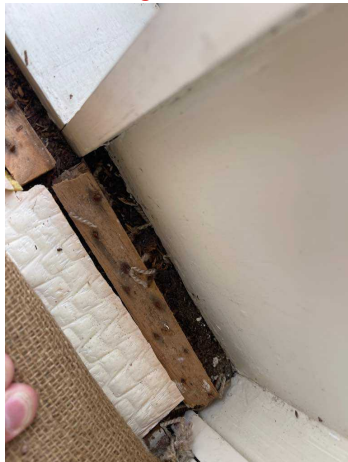
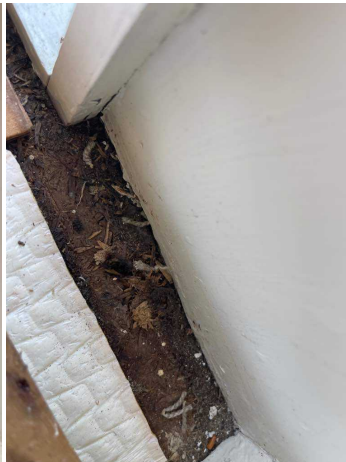
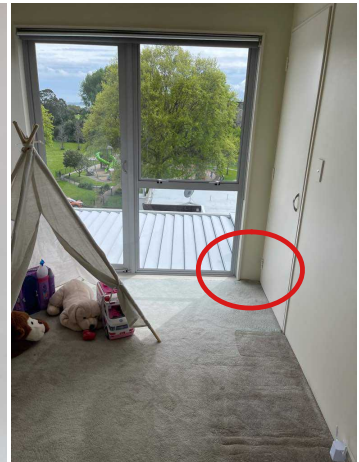
Floor: Carpet - **There is signs of water ingress invasive inspections required. The floor is rotten.**

(Weathertightness concerns)

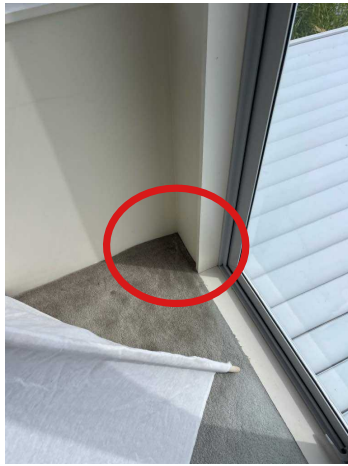
28. Defective

Doors: Aluminum - This door opens up to the outside which is on to a louvre roof System the door should be permanently closed it only has one screw at the bottom

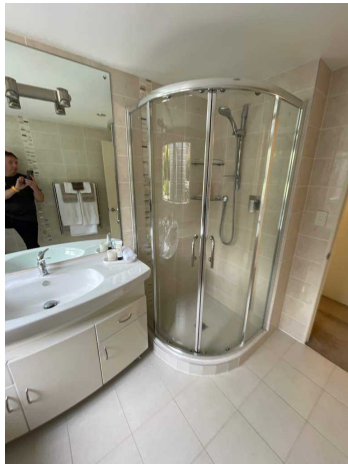
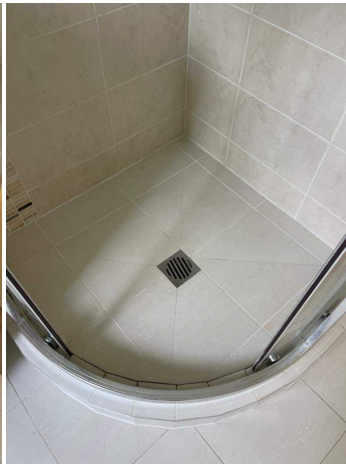
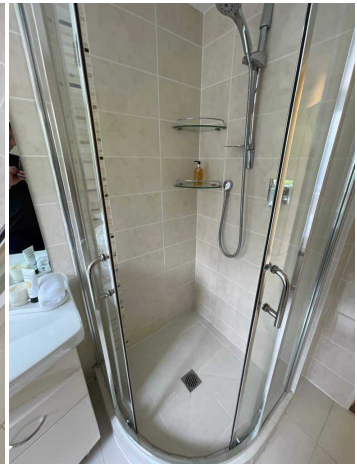
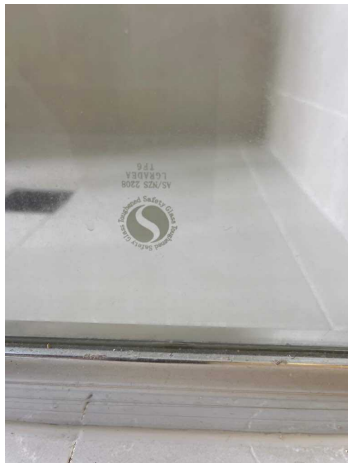
Shower: Tiled wall and base - Showers must be serviced every three years to prevent leakage resulting to costly bills. We would recommend checking to see if the shower is consented due to no enclosure water will splash every ware, note also there is no additional floor waste if this flooded water can travel into the other areas of the home.

Important note, tiled showers must be serviced ever 3 to 5 years due to movement, failing to have them checked can result to very costly repairs.

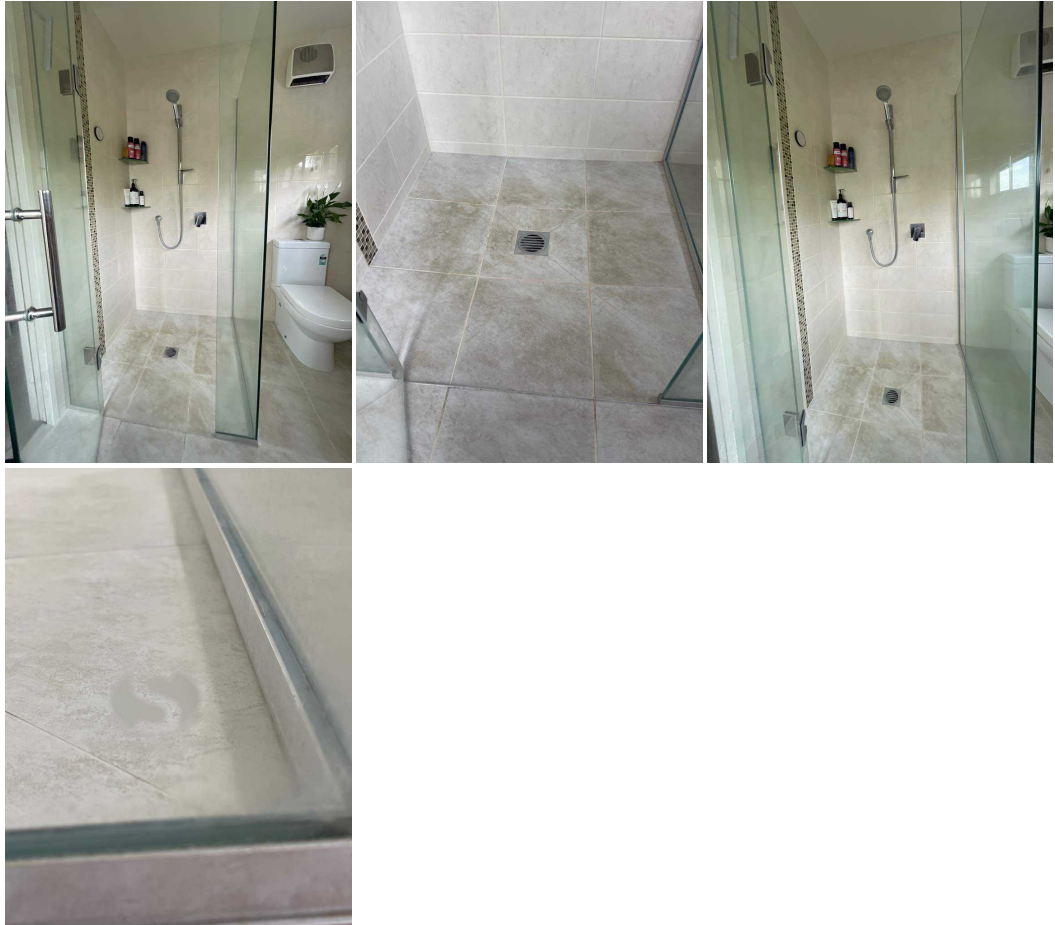
Shower: Tiled wall and base - We would recommend checking to see if the shower is consented due to no enclosure water will splash every ware, note also there is no additional floor waste if this flooded water can travel into the other areas of the home.

Important note, tiled showers must be serviced ever 3 to 5 years due to movement, failing to have them checked can result to very costly repairs.

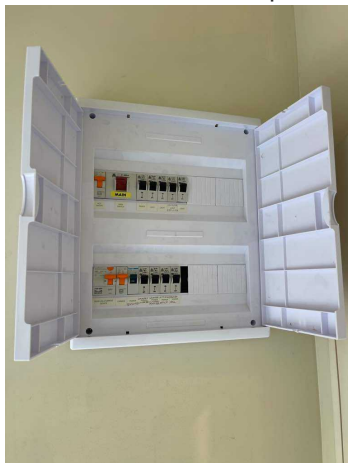
- Laundry Electric Panel _____
- 1. Area Inspected We highly recommend obtaining the electrical certificate for the new wiring board.
- 2. Not Inspected Switch Board Not inspected

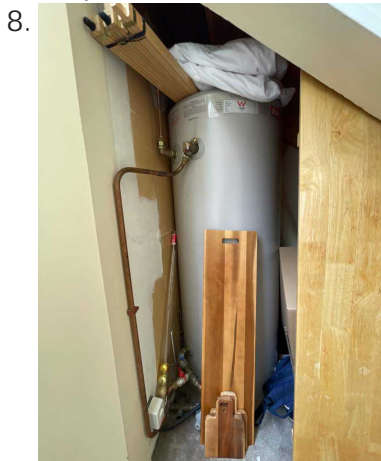
Hall cupboard Water Heater

9. Comments Will require top and bottom holding straps and a tray installed beneath
10. Acceptable Water Heater Operation: Functional at time of inspection
11. Acceptable Power On/Off On
12. Manufacturer: Dux
13. Type: Electric Capacity: 180 litres

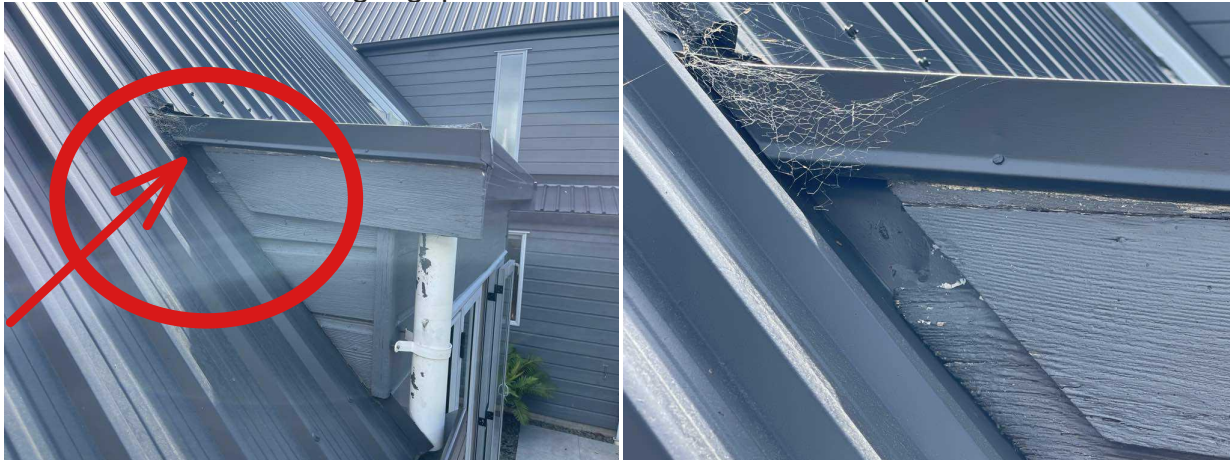
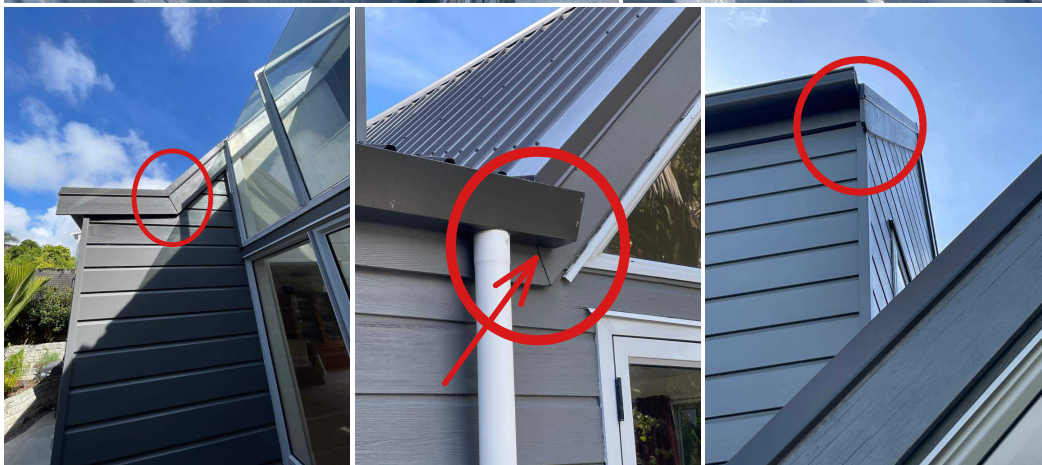
1. E.g. Corrugated Iron, Pitched, Timber Framed Etc Roof Surface Barge Boards: Painted timber - The timber barge board is too short leaving a gap at the end this will need to be replaced

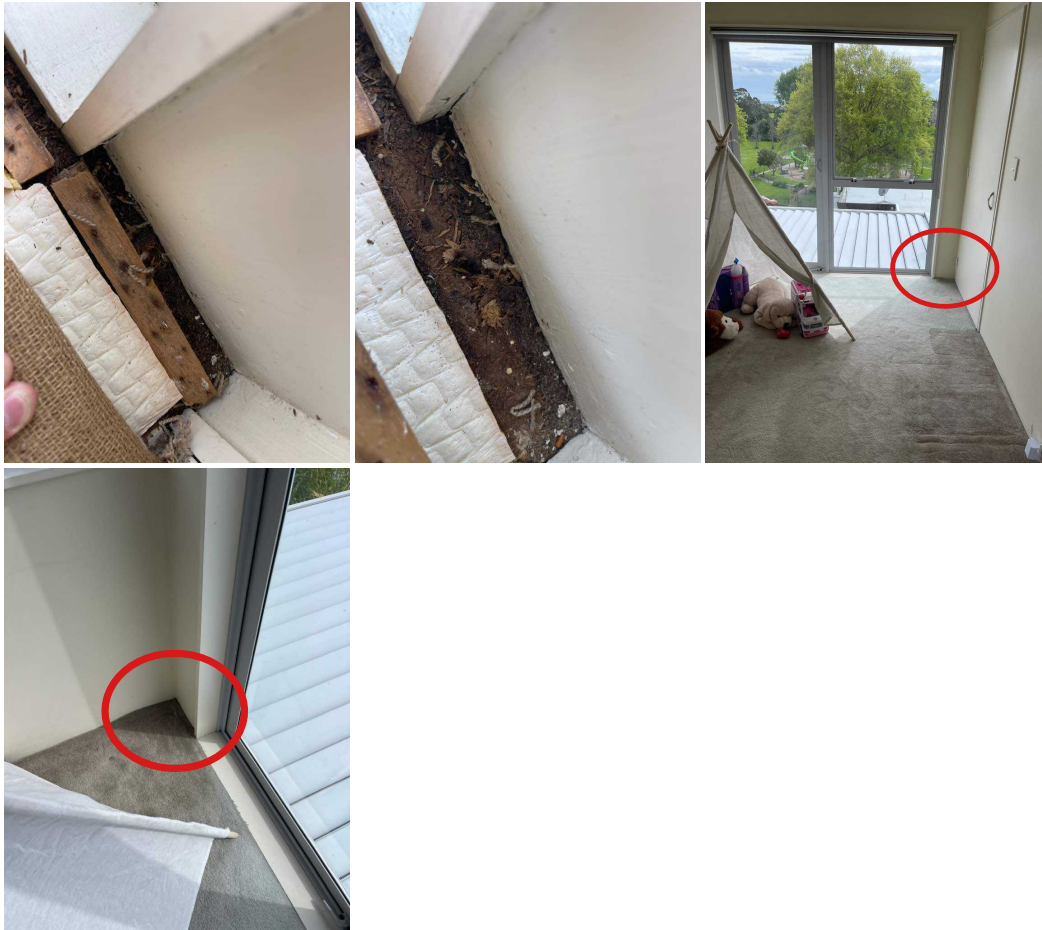
3. Bedroom 3 Bedroom Floor: Carpet - There is signs of water ingress invasive inspections required. The floor is rotten.

4. Bedroom 3 Bedroom Doors: Aluminum - This door opens up to the outside which is on to a louvre roof System the door should be permanently closed it only has one screw at the bottom

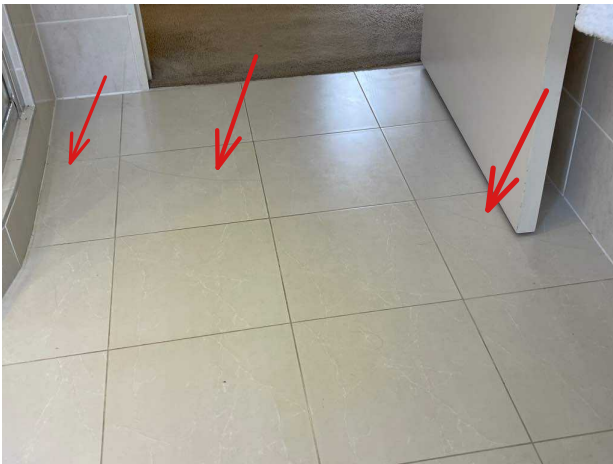
5. Main Bathroom Bathroom Floor: Tiled with no underfloor heating - The floor tiles are cracked these will need to be replaced however the tiles may now not be able to be matched which may result to replacement on all walls and floors

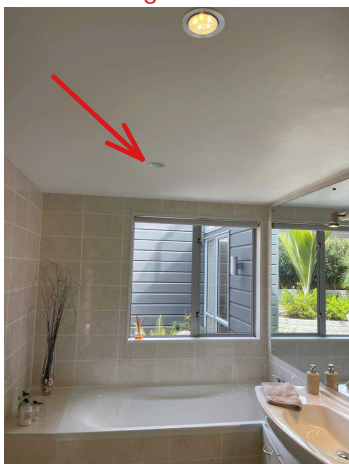
6. Main Bathroom Bathroom Electrical: Wiring has not been inspected or tested as part of this inspection - **The light is not working over the bath**

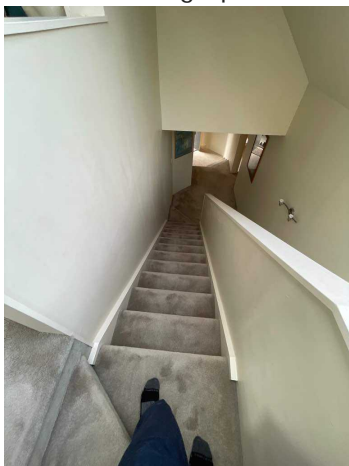
7. Stairwell Living Space Handrails: Not fitted - **A handrail will need to be installed**
